NASA Contractor Report 3404

Development and Validation of Cryogenic Foam Insulation for LH₂ Subsonic Transports

F. M. Anthony, J. Z. Colt,
and R. G. Helenbrook
Bell Aerospace Textron
Buffalo, New York

Prepared for
Langley Research Center
under Contract NAS1-10969

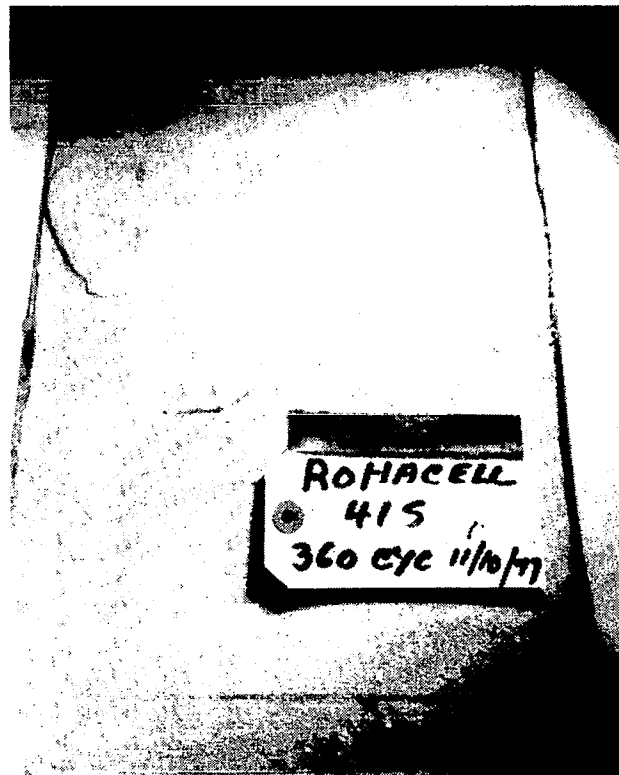
Figure 30. Rohacell 41S After 360 Cycles

Rohacell 41S, Material 5, which contains a flame retardant additive, was badly damaged at the time of first inspection and, therefore, the specimen was removed after only 371 thermal cycles. The initial performance was only fair; the structural failures were extensive.
